Content: **Test Report Conclusion**

Project: Bohle VetroMount Top and VetroMount Side

Project number: VT 17-0682

Report: VT 17-0682 - 13

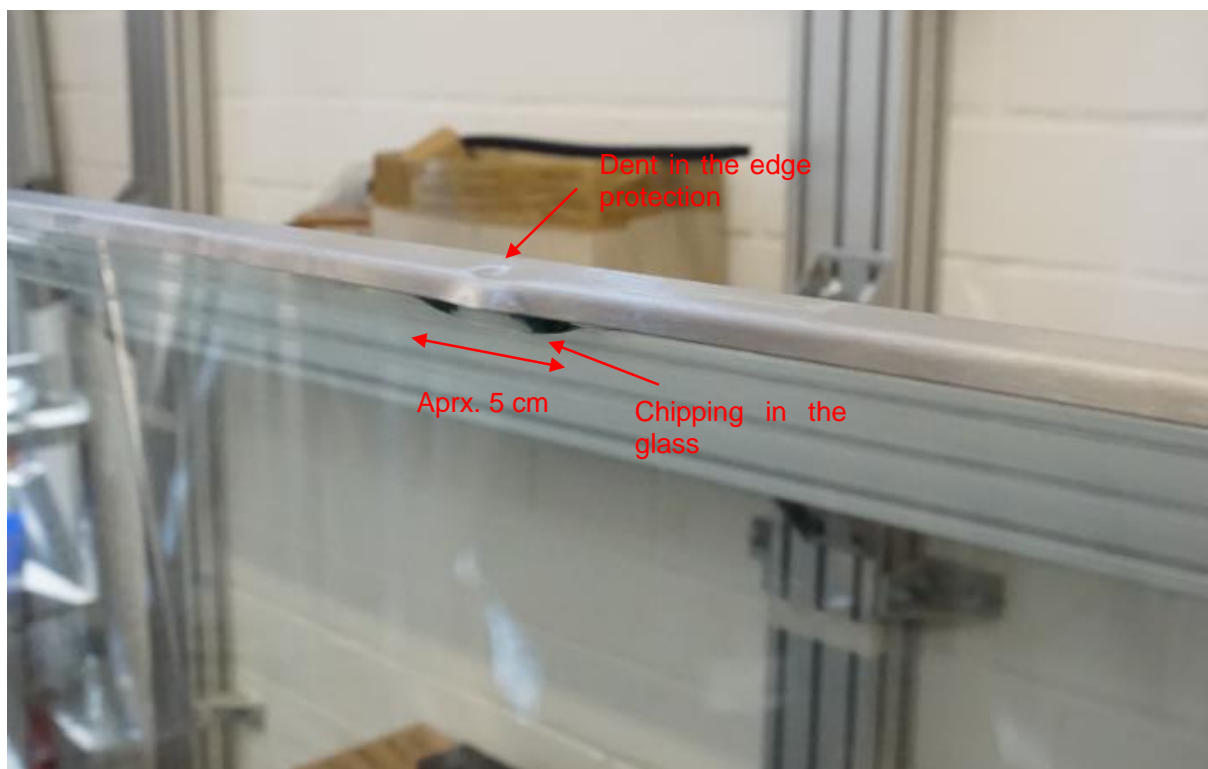
The designs of the edge protection listed in Image 12 and Image 13 do not comply with the specifications of DIN 18008-4 and therefore, the verification of the edge protection must be provided in accordance with DIN 18008-4 Appendix E. The edge protection test is to be executed as a "hard impact test". These tests shall be conducted with a steel ball with a diameter $d = 63,5$ mm and mass $m = 1,03$ kg.

Image 26 Chipping in the glass after testing the edge protection with the hard impact test

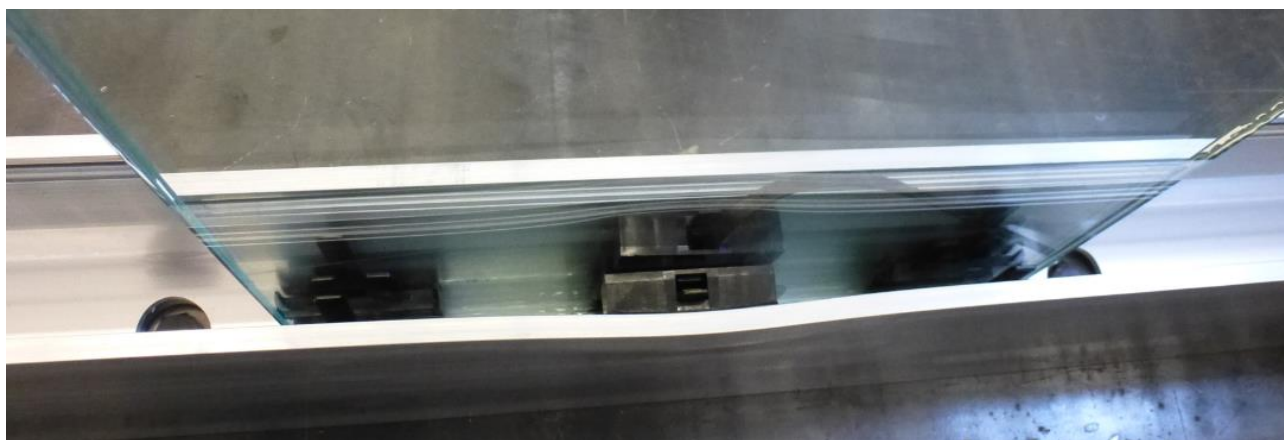
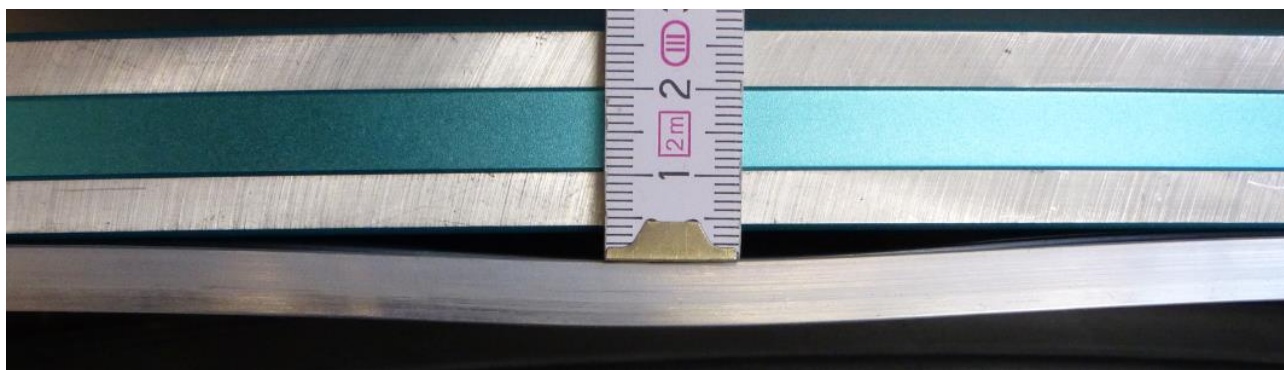
Image 27 Bulging (4 mm) of the profile after the test with the width 300 mm

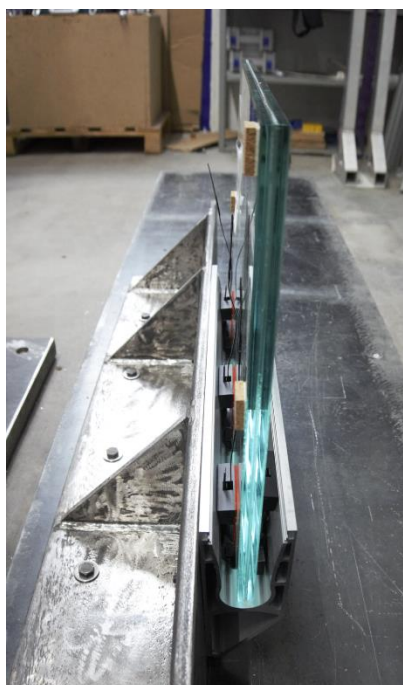
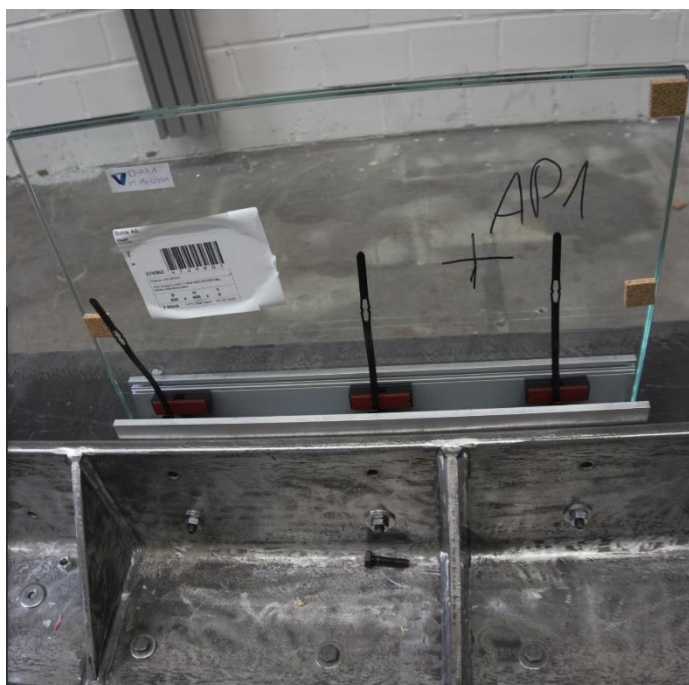
Profile	Glass assembly	Width / height [mm]	Handrail-System	Fall Height [mm]	Impact Point	Result
VetroMount Top	88.2 ESG	500 / 400	α	900	A1	No visible damage to the glazing, bending of the profile, passed
VetroMount Top	1010.2 TVG		α	900	A1	No visible damage to the glazing, bending of the profile, passed
VetroMount Side			α	900	A1	No visible damage to the glazing, bending of the profile, passed
VetroMount Top	1010.2 heat soaked ESG	300 / 400	α	900	A1	No visible damage to the glazing, bending of the profile, passed
VetroMount Side			α	900	A1	No visible damage to the glazing, bending of the profile, passed

**Image 28** Test results for small glass formats

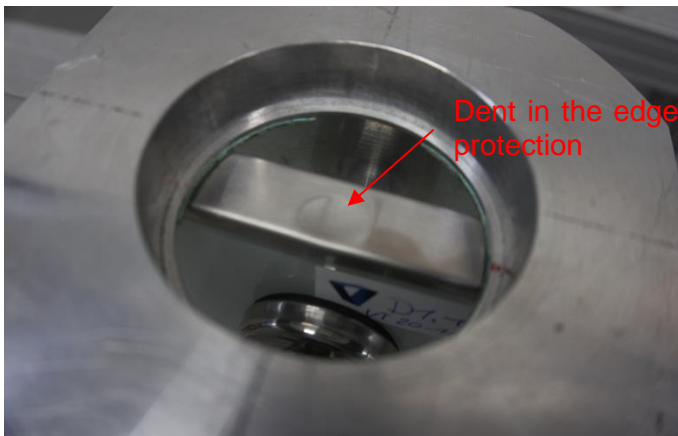
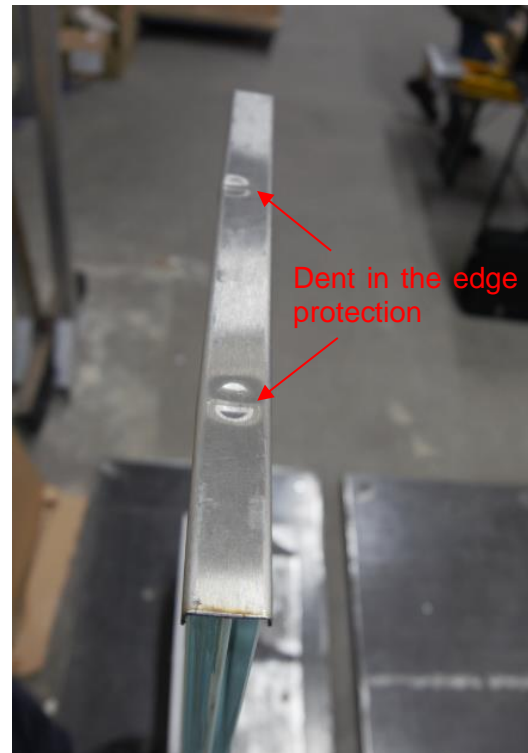
*On these test samples the edge protection was also tested. The edge protection tests were carried out on the glasses with the edge protection profiles (system α) given in Image 12. The ball with the fall height of 2000 mm left dents in the edge protection but did no damage to the glazing.

Image 29 Result after the hard impact tests on enamelled glass (dent in the edge protection)

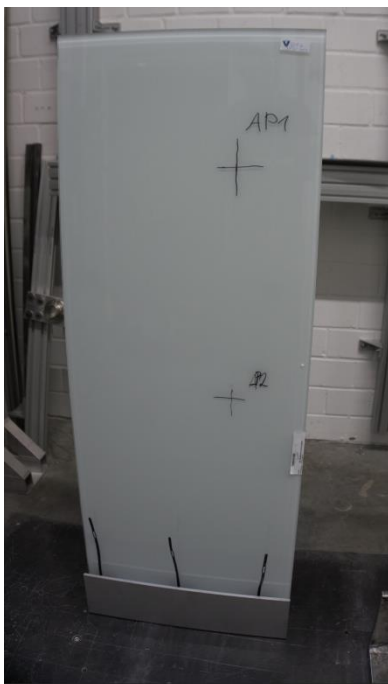
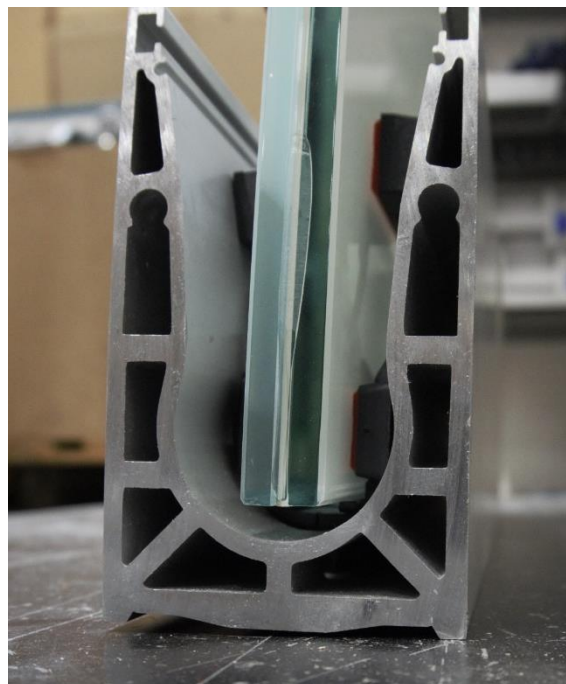
2		No visible damage to the glazing, light bending of the profile in the area of the screws
Vetromount Top	88.2 VSG of enamelled ESG	300 / 400	900	α	4	2 / 3	No visible damage to the glazing, light bending of the profile in the area of the screws
Vetromount Top			900	α	1	2 / 2	No visible damage to the glazing, light bending of the profile in the area of the screws

Image 30 Results of 88.2 enamelled ESG
