Content: **Test Report Conclusion**

Project: Bohle VetroMount Top and VetroMount Side

Project number: VT 17-0682

Report: VT 17-0682 - 13

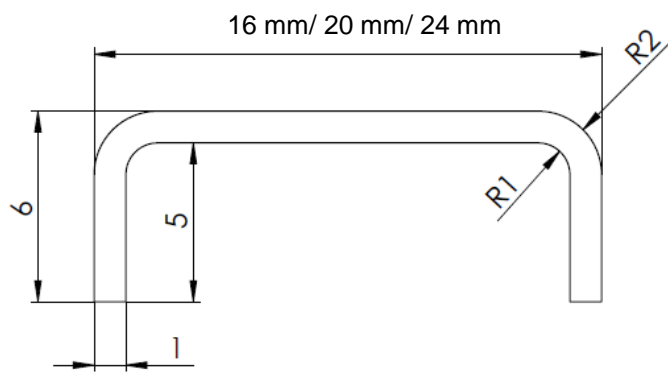
Image 12 Stainless steel Edge protection

The designs of the edge protection listed in Image 12 and Image 13 do not comply with the specifications of DIN 18008-4 and therefore, the verification of the edge protection must be provided in accordance with DIN 18008-4 Appendix E. The edge protection test is to be executed as a "hard impact test". These tests shall be conducted with a steel ball with a diameter $d = 63,5$ mm and mass $m = 1,03$ kg.

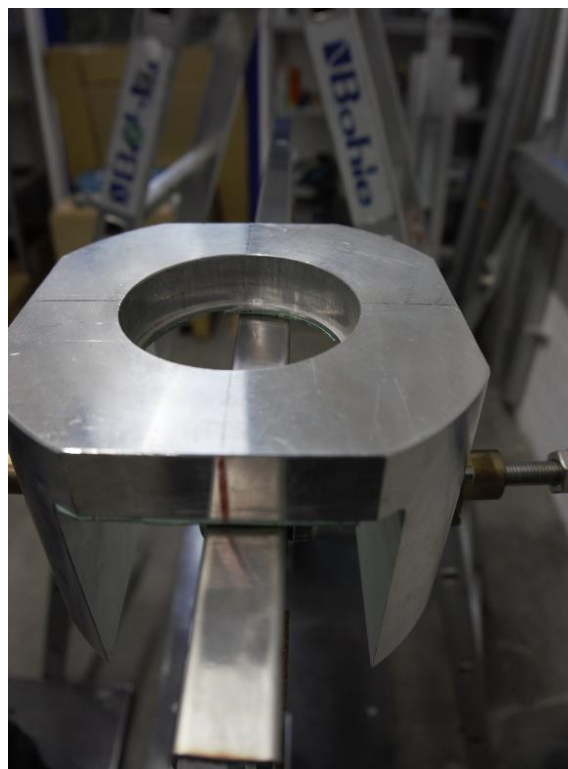
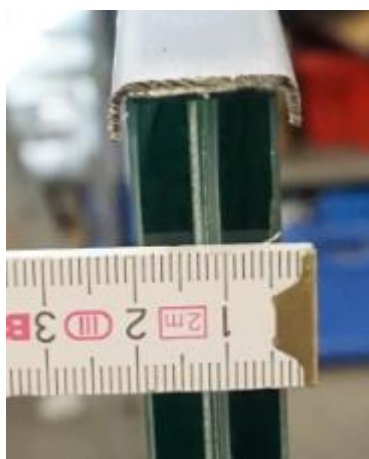
Image 23 Tested edge protection

*the tests of the edge protection were performed before the dynamic tests. The edge protection tests were carried out on the glasses with the edge protection profiles (system α) given in Image 12. The ball with the fall height of 2000 mm left dents in the edge protection. In a few tests, chipping occurred in the glass at the point of impact with a diameter of approx. 1 cm Image 26. These results had no negative effects on the afterwards performed pendulum impact tests.

*On these test samples the edge protection was also tested. The edge protection tests were carried out on the glasses with the edge protection profiles (system α) given in Image 12. The ball with the fall height of 2000 mm left dents in the edge protection but did no damage to the glazing.
